Site Plan Notes Varda Residence

1918 West Cedar Lake Parkway

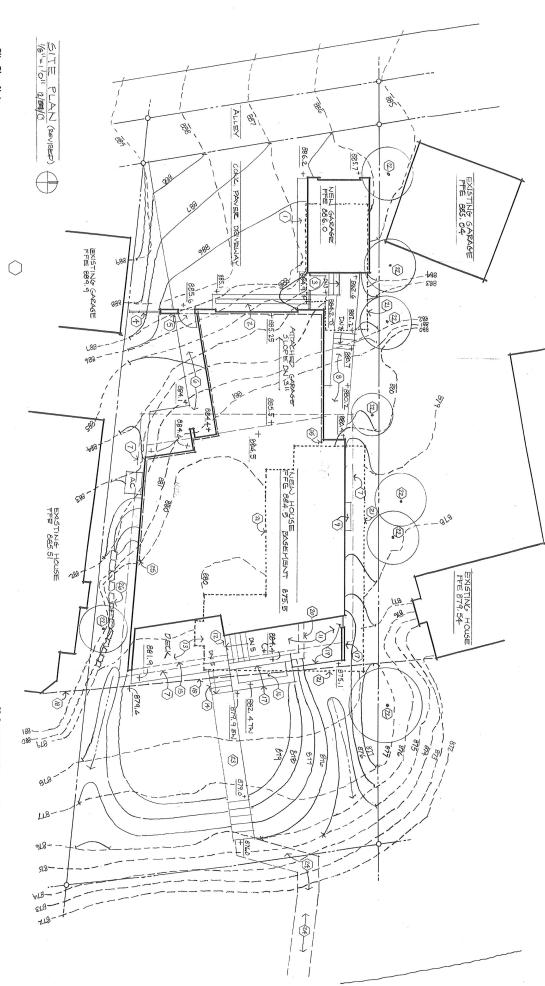
- All dashed contour lines are existing. Solid lines are
- proposed.

For existing conditions refer to certified survey dated July 23, 2013,

Existing house and garage to be demolished and removed.

Locate new house on property by setting southeast corner of living roam deck at settank line. North façade to be 60° south of north property line. New detected garage to be 60° west of new attached garage and 1'6" south of north property line.

1. Planting bed along new garage
 2. Trench drain with steel grating set in concrete apron along
 2. Trench drain with steel grating set in concrete apron along
 3. 60° high soild wood fence and gate,
 4. 60° high soild wood fence and gate,
 5. 80° high stone wall with soild wood gate. See elevations,
 6. Concrete paver walk and patio,
 7. Line of second floor roof edge.
 8. Concrete walk/steps to side entry, 6° risers and 12" treads,
 9. Projecting bay for lower level gas fireplace,
 10. New concrete stoop at lower level siding door, Stoop fills area under north end of deck. Elev 775.4 at door, Slope 2%,
 11. New wood deck at elev, 884.4,
 12. Wood steps down to lower deck. 5 risers at 6°. 12" treads,
 Footlights centered in each riser.
- 13. Wood lower deck at elev. 883.9. Grade at foundation wall under decks is 880.0.
 14. Wood steps down lawn. 5 risers at 6". 12" treads. Footlights

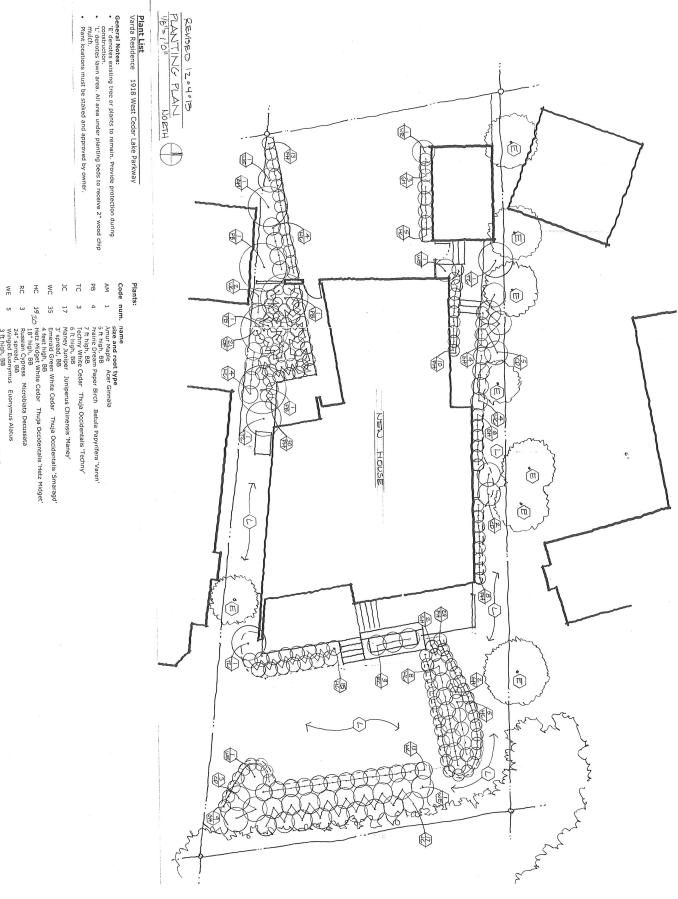
4 feet high, BB Hetz Midget White Cedar Thuja Occidentalis 'Hetz Midget' 18" high, BB

Aussian Cypness Microbiata Decussata
Aussian Cypness Microbiata Decussata
Auf spreach, Marymus Euonymus Alakus
Arrigel Boyymus Euonymus Alakus
Arrigel Boywood Cornus Sericea 'Cardinal'
3 It high, B
Francee Hosta Hosta Francee

Guacamole Hosta Hosta 'Guacomole'

rich Fern Matteuccia Strutheriopteris

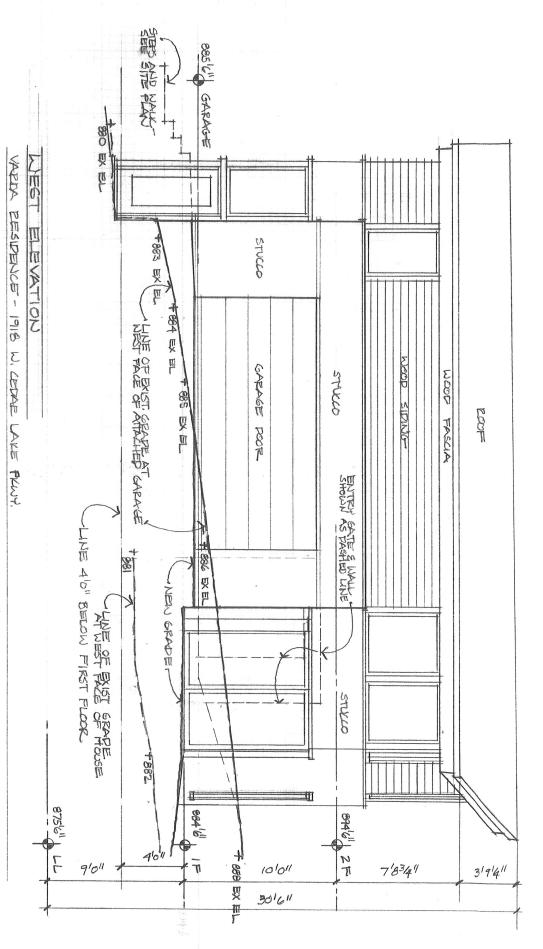
PLEASE COORDINATE WITH SITE PLAN TO MEASURE EXIST (NORMAL) GRADE AT HOUSE PERIMETER
